Pacific West Home Inspections

Report #: 2743-2010

RE: Exterior Deck Stairs Construction Inspection

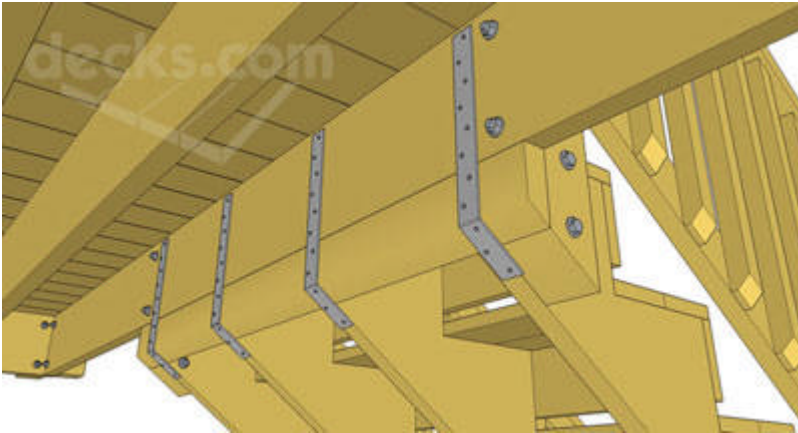
4.8. Stair Stringer Attachment: Presently viewed, 1/2" untreated plywood is attached directly to the outside surface of the deck's metal flashing. The plywood itself is only attached with 11 separate #8 - 3" metal screws which are not full thread type. It appears that all of the stair stringers are attached to a untreated 2x4 attached along the bottom of the plywood sheathing. By appearance, all three of the stringers are then connected individually by one small metal angle bracket at one side of the stringer. Each of the small metal brackets are fastened into place with a total of four #8 - 1" metal screws to each of the wood members with the exception of one bracket that has one additional screw.

4.8.1. Recommendation: The present construction, the stair stringer attachment appears to be poorly installed and material used likely to be under sized.

How one attaches the stair stringers to the top of the deck and to any landings is critical. It should be reinforced at the rim behind the stairs to provide a solid base for attachment. Need to install positive connections to install stair stringers using joist hangers and/or angled brackets to the front face to provide adequate support.

The first tread steps down from the deck must extend the rim joist to create a solid surface below the deck rim to attach to. You should attach a 2x6 or 2x8 under the rim flush to the bottom of the stringer using strap ties or bolted cleats for added strength. Also additional use of metal strap ties can be bend along the bottom of the stringer and over the top of the rim joist for added support (see diagram example below).
