Report Table of Contents

INSPECTION INFORMATION & CONDITIONS

TYPE OF INSPECTION: New Home Inspection.
FILE #: 2987-2011.
DATE OF INSPECTION: July 20th, 2011.
TIME OF INSPECTION: 12:06 pm to 5:32 pm.
CLIENT NAME: Mr & Mrs Smart.
CLIENT ADDRESS: 1234 New Home Drive
 Shuswap, B.C.
CLIENT PHONE #: 250 123-4567.
EMAIL ADDRESS: smarhomeowner@hotmail.com.
INSPECTION SITE ADDRESS: 1234 New Home Drive
 Shuswap, B.C.

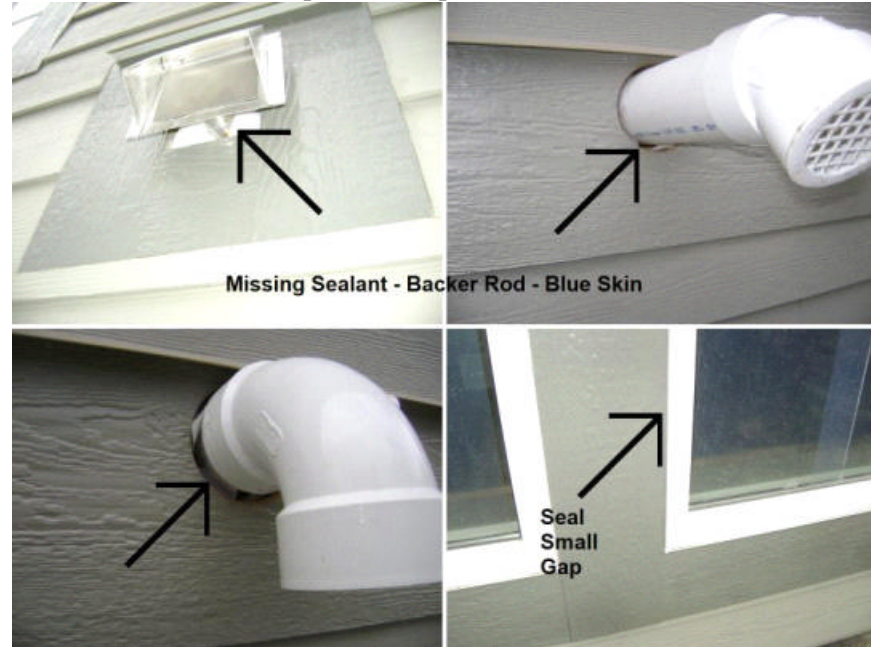
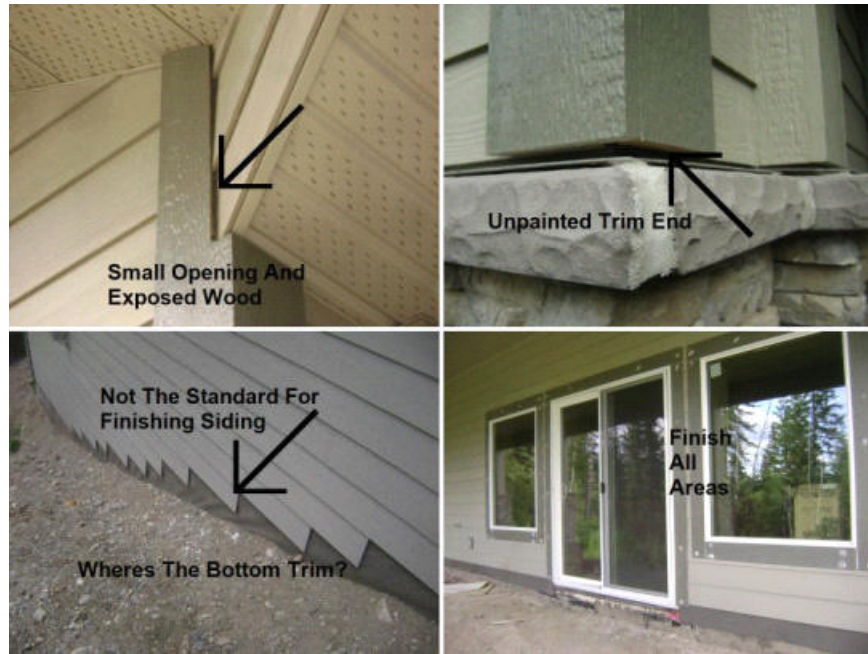
PHOTOS A: Exterior Trim.

Appears serviceable overall, however, the following issues are observed at various locations to the exterior of the homes trim:

1. Paint and/or seal all cut ends that are potentially susceptible to exposure to weather conditions such as wind driven rain and snow (prevent wood material from swelling and development of wood decay).

2. Seal around the perimeter of the windows where the trim meets along the edge where small openings/gaps are observed. This will prevent exposure to weather conditions such as wind driven rain and snow (prevent water from penetrating to areas behind the trim and siding).

5. All exterior penetrations need to be sealed. Observed two areas at the east side of the home that have not been sealed which are the master bedrooms laundry dryer vent cover and the hot water tanks air inlet and exhaust pipes. Both require round foam backer rod, sealed and the opening having applied "Blue Skin Breather" type membrane installed (as per architect drawings - typical construction standard and practice). This needs to be completed and finished correctly by today's building standards and practice. Since this appears not to be installed at these two locations, this raises the question if those sealant materials and membranes were installed at all other wall exterior penetrations.

7. Unfinished trim observed at the lower south area of the building along the bottom of the siding, below the sliding glass patio door and the nail fastener points on the surface of the trim around the windows.

8. Some unfinished, exposed trim ends are observed at the south area of the home and therefore need to be painted for protection.

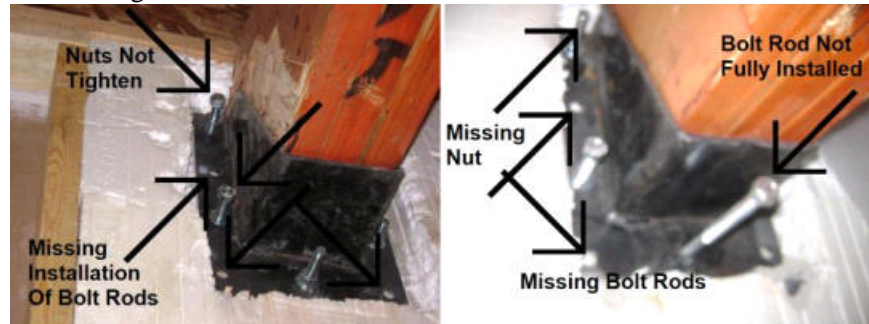
Observation One: Within the northeast room (storage room), there is a large, main support beam installed from the east foundation wall to the west wood framing wall. The beam is supported with manufactured pocket type metal brackets at both ends. Viewed that a number of the bolt holes in the metal bracket to install metal thread type bolt rods have no bolt rods installed and that only a few of the bolt rods have been installed and the metal nut is not fully fastened (to a few). Since there are a

specific number of holes for metal bolt rods to be installed and that only a few have metal bolt rods having been installed, because of that specific number, I'm sure it was the professional designers intentions that a number of bolt rods where to be installed with metal washers and nuts. Why the absence of bolt rods from the other holes within the metal bracket is not known. I recommend to inquire with the buildings architect if the absence of the bolt rods that have not been installed is ok to the design.

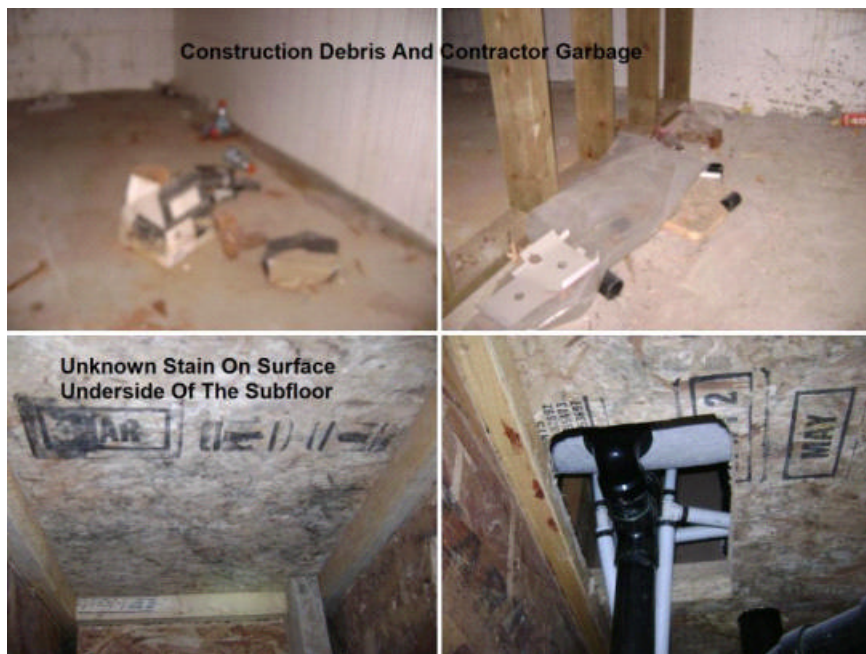
Observation One: No mechanical or natural venting of the crawl space was observed (hidden or not installed?). Recommend to install some type of venting

within the crawl space or have heated (present conditions are humid, stale air and signs of unknown type of staining on the underside surface of the subfloor plywood sheathing).

Observation Two: Contractor left personal and building debris in the crawl space, have cleaned.

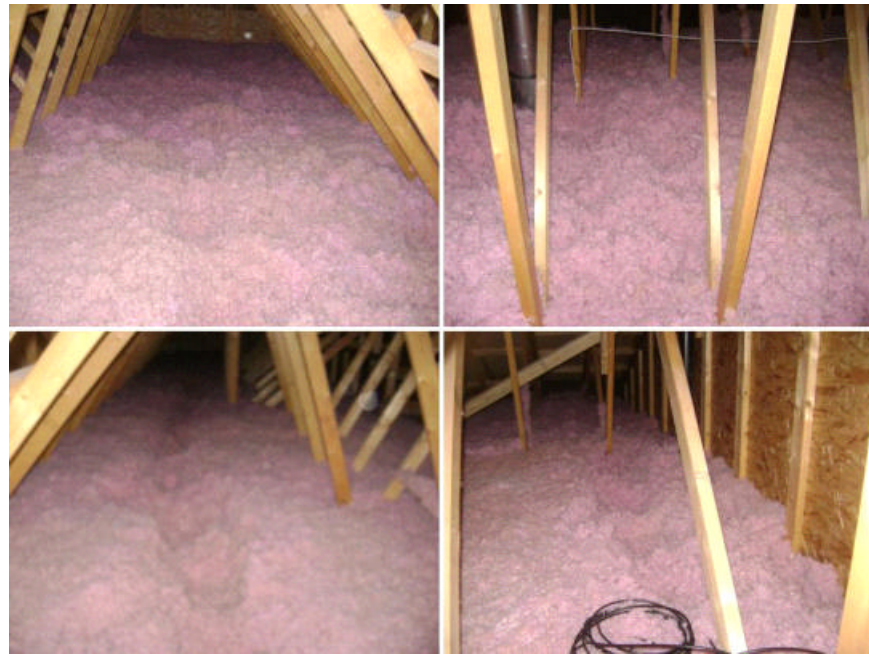
Condition: Insulation is installed between floor trusses/joists of the attic. Insulation is somewhat compacted at various locations (sub-trades?) and the true R-factor at this point in time may be substantially less than that originally installed. Installation of additional insulation is recommended.

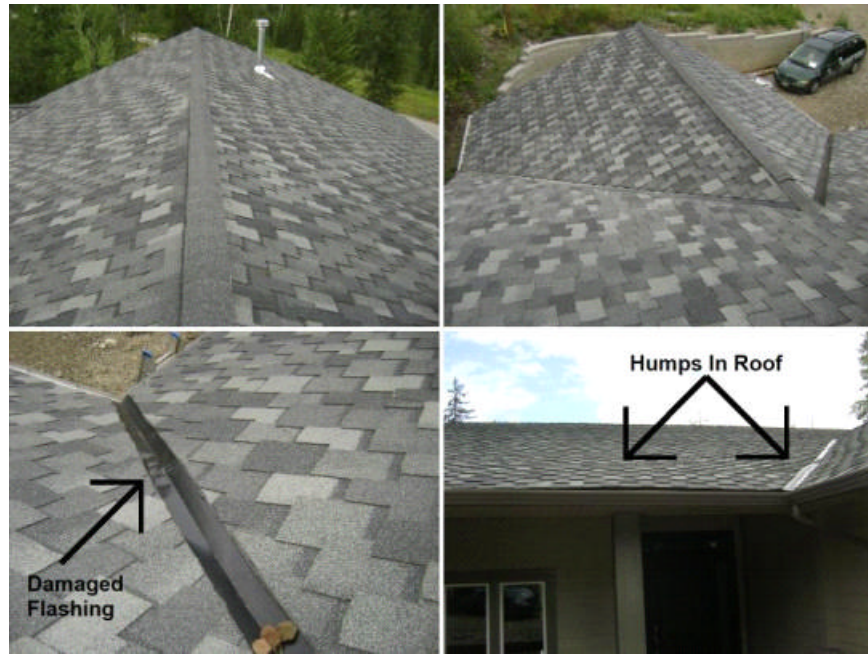
ROOF COVERING STATUS: The following conditions and issues to the roofs covering material at various locations are observed:

1. At the lower north central are of the roof, there appears to be an oddity on the surface of the roof. It appears that this area of the roof between where the house roof and garage roof meet within the roof valley humps slightly and that a section of the valleys metal flashing is damaged. By appearance, it appears that this area of the roofing material (assuming due to limited viewing) and the valley flashing are not secured to the deck of the roofs sheathing membrane.
2. Small roofing debris (cut ends, etc) are observed at the south side of the roofs surface (contractor clean up?).
3. At the north side of the roof, along the edge at the front door entry, a section of the roofing material is torn and should be replaced (this is a new roof - deficiencies should not exist).

Conclusion And Recommendations: Recommend to obtain the professional roofing contractor that installed the roof covering and flashing materials to further investigate roof covering oddity (area where hump and loose shingles are noted), replace the metal valley flashing of which is damaged, clean left over roofing material debris and replace the torn shingle at the front north side of the roof.

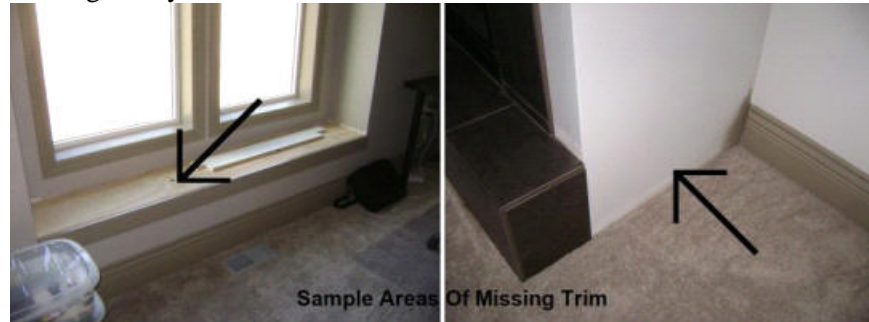
Appears serviceable overall, however, viewed several areas where the trim is missing or is yet to be installed.

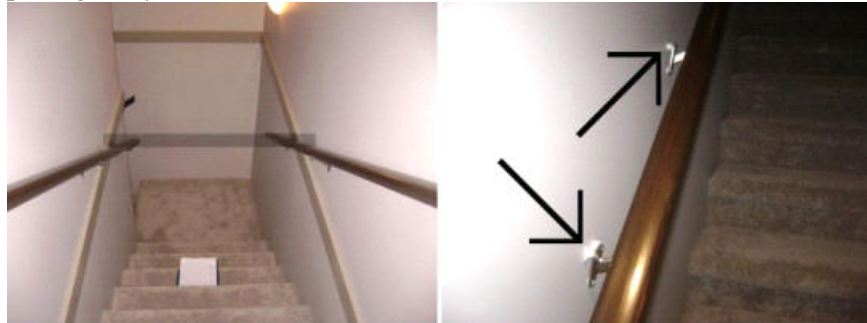
Condition of Hand Rails: The following issues and concerns of the hand rails and related components are observed.

1. Upper section of the stairs, the bottom of the right handrail is higher then the bottom of the left handrail.
2. Lower section of the stairs, the right side of the hand rail fasteners are loose and pulling away from the wall.

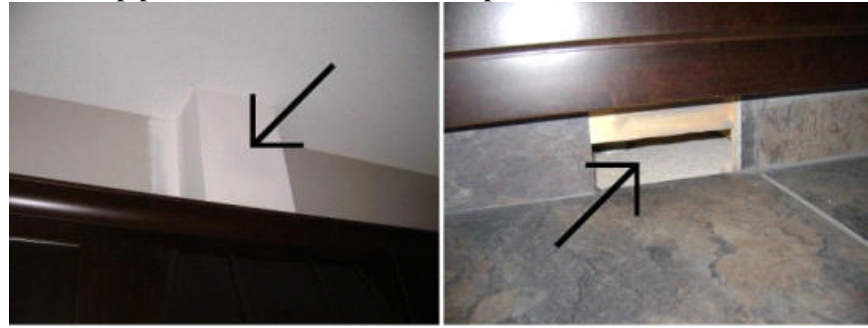
sink (below area of the microwave oven), the indoor vacuum floor kick-out cover and duct pipe are not installed (non-completed).

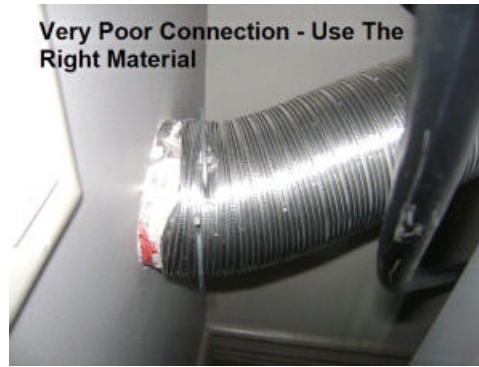
The following conditions and issues to the laundry facilities are observed:

1. The dryer appliances venting material should be replaced with 4 inch metal smooth pipe with a good connection to the wall metal pipe with all joints wrapped in metal tape. Reason, the present aluminum flexible pipe can collect moisture/condensation (has small ridges) and therefore mold and mildew will develop along the bottom areas of the pipe.

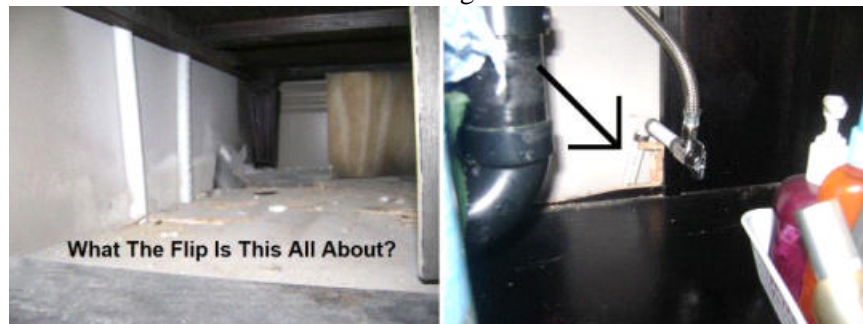
1. The hot and cold water service lines are installed through the floor and enter from the back of the cabinets.
2. Stone tile is not installed within this area underside of the cabinets (exposed wood subfloor and construction debris).
3. A small section of drainage is exposed from the edge of the floor and wall.
4. Finishing trim is not installed along the back wall to the floor.
5. Within the floor cabinet, a portion of the cabinets back cover has been hacked away.

By appearance, the present conditions viewed could have been avoided with the hot and cold water pipes installed within the interior wall and both exiting just above the floor cabinets shelf without hacking the back wood wall of the cabinet.

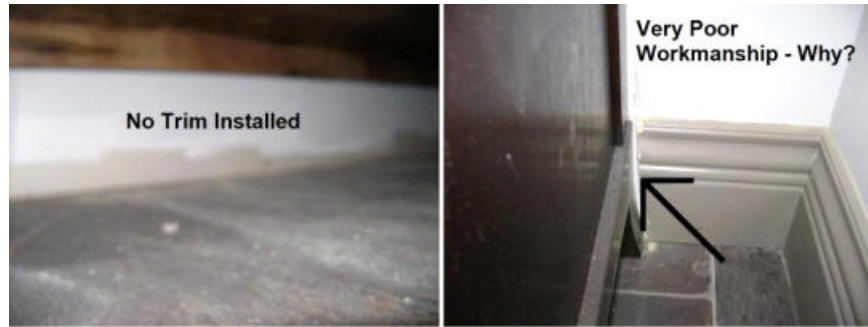
Observation One: The sink counter does not have a back splash installed.
Observation Two: The sinks drain stopper connection at the drain pipe leaks.
Observation Three: Finishing trim is not installed along the back wall to the floor.
Observation Four: Finished wall trim ends at the left and right of the floor cabinets have poorly finished ends.

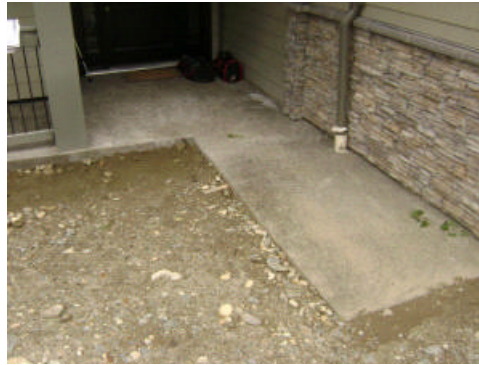
1. Top surfaces of the concrete is poorly finished (not consistent).
2. Surface of the concrete is uneven (dips).
3. Surface of the concrete has a negative slope at various locations. The sidewalk needs to slope away from the foundation and main doorway entry from the building.

Due to the present installation and finishing of the concrete sidewalk, the concrete needs to be removed and replaced with new aggregate concrete and finished by today's building standards and practices.

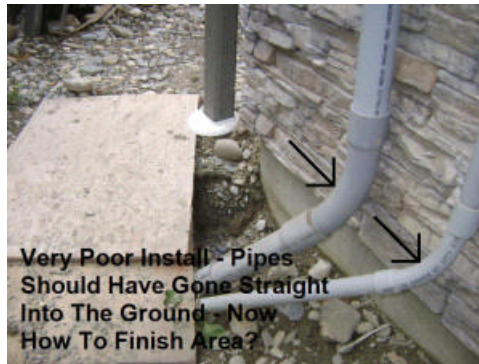
Exterior grounds need to be landscaped.

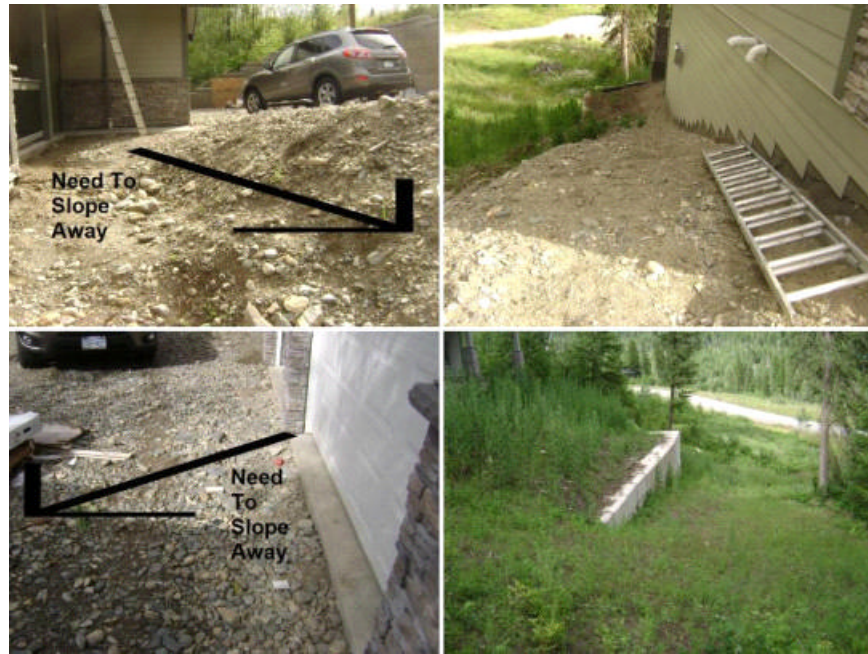
1. North side of the home.
2. East side of the home.
3. West side of the home.

Need to grade slope of soils away from foundation, garage entry area, and main front area sidewalk. The slope should fall away from these areas at a minimum of 1/2 inch per foot and extend at least 10 feet away from the foundation, sidewalks and garage if possible for proper drainage of water.

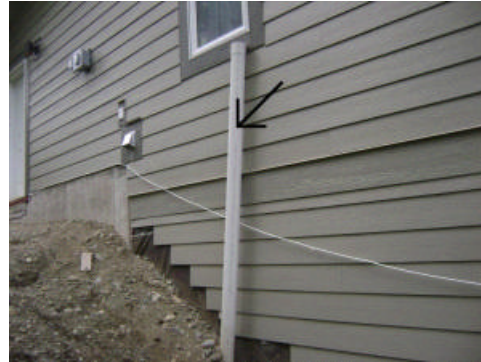
Note: Perimeter drainage clean out pipes are viewed around the perimeter of the building. Several need to be lowered to a reasonable height of which should be at least 12 inches from finish grade and capped.

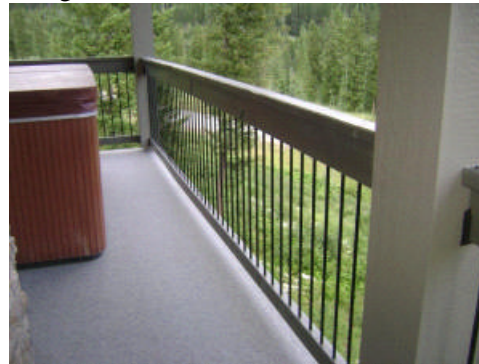
2. Span length of the longer sections of the guard railing appear to need mid span support such as an additional 4x4 column post as the railing moves considerably. The design strength for a guard rail should resist a horizontal load of 100 lbs or concentrated load of 200 lbs applied inward or outward at any point at the top of the guard. The top of the guard rail shall resist an evenly distributed vertical load of 300 lbs (appears doubtful by trial).

3. The far southeast guard railing does not fit squarely even between the column supports (poor install).
4. Wood material used is very rough and appears to be a poor choice (used from building scrap?). Guard railing is a feature and better choice of wood (smoother, straight and with minimal defects) should be used.

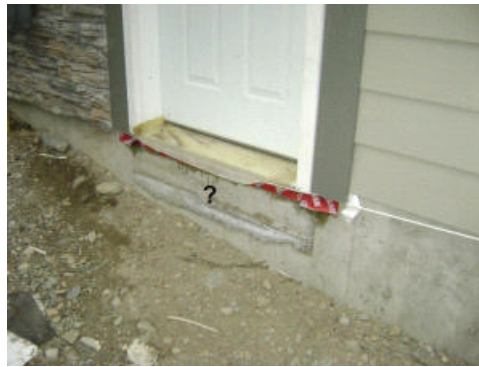
Condition of Stairs: No stairs or landing has been designed or constructed. This poises a falling hazard. Need to design and construct by todays building standards and practices a stair or landing within this area.

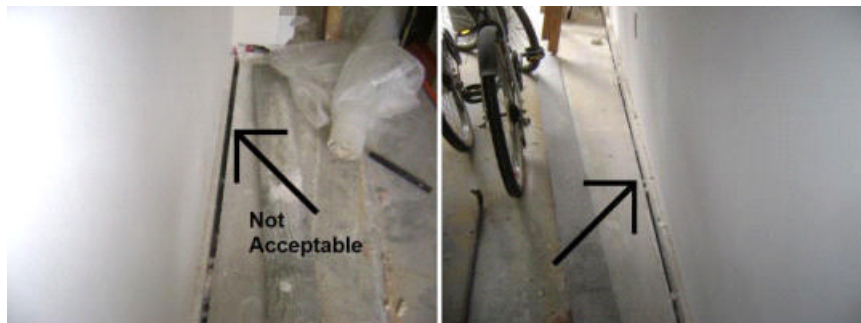
FOOTING WALLS - TYPE: Poured concrete.
CONDITION: Appears that the east wall foundation/footing has settled (moved). A significant opening between the foundation footing and edge of the garage floor is viewed. Typically, such an occurrence is due to certain unknown ground condition oddities, insufficient compaction of natural soils or gravels or water intrusion underside or around the foundation footing. Not much can be done about the present situation of which should not have never occurred in the first place, but these type of things can happen if design and construction is lacking a certain amount of attention. One solution is to replace the foundation footing and pour another of the same design but that would be a significant expense and time. Recommend to monitor this area within the garage for approximately for a year to see whether the gap expands by movement or the exterior wall moves such as cracks in the drywall board. If not, have the building contractor return then and fill the gap opening with a round type of foam gasket and top up with concrete mortar or an rubber expanding compound sealant which would be a better choice as this would allow for possible expansion and contract movement.

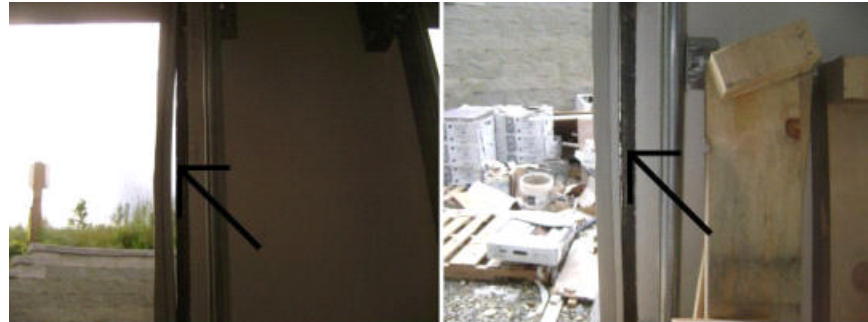
GARAGE ISSUES: **Observation One:** No filler trim installed around the inside of both vehicle doors (left, right and top areas). Further, plastic flashing trim is loose (poor install).
Observation Two: No trim installed around the inside of the west exterior door.
