# **Report Table of Contents**

# INSPECTION CONDITIONS

**FILE #:** 2746-2010.  
**DATE OF INSPECTION:** July 5th, 2010.  
**TIME OF INSPECTION:** 10:26 am to 3:38 pm.  
**CLIENT NAME:** Mrs Jon Jet.  
**CLIENT ADDRESS:** 1111 Anywhere Street  
Salmon Arm, BC.  
**CLIENT PHONE #:** 250 111-1111.  
**EMAIL ADDRESS:** greathome@unknown.ca.  
**INSPECTION SITE ADDRESS:** 2222 Homes Street  
Blind Bay, BC.

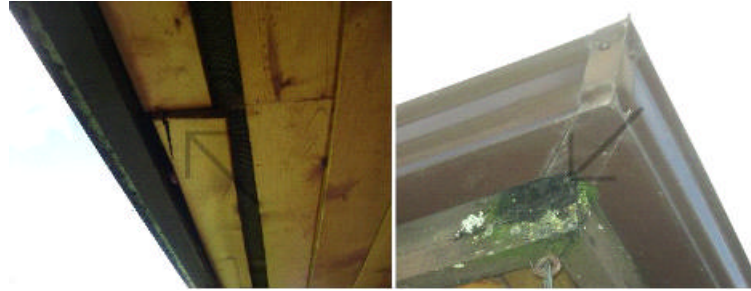
Appears serviceable overall, however, the following issues are observed at various locations to the exterior of the homes trim:

1. Fascia trim at a few locations exhibit surface deterioration and staining due to water leakage from the gutters where leaking joints are located.
2. North side of the home, roof overhang, some of the wood soffit material is damaged, reason unknown (inquire with current homeowner).
3. West basement windows have not metal header flashing trim installed.
4. East garage windows have no metal header flashing trim installed.

Obtain the professional services of an renovation contractor to perform repairs and/or material replacement as and where needed to protect building materials.

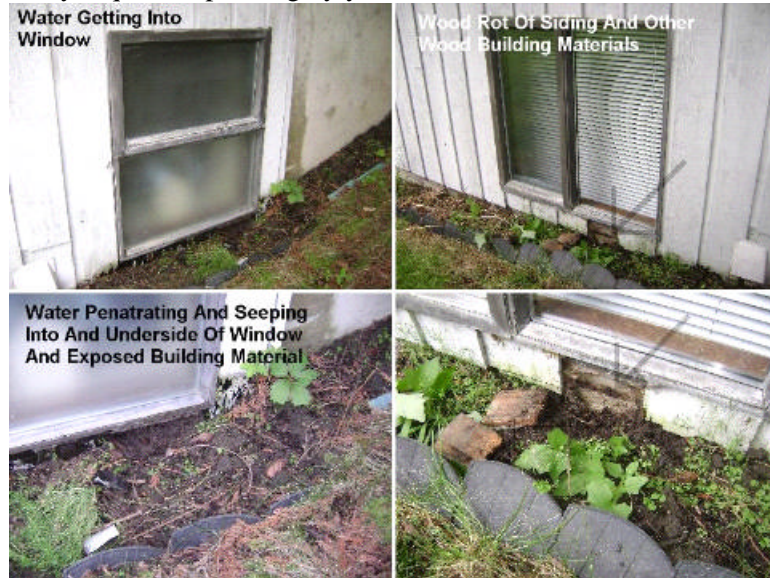
**Observation One:** The lower sections of the wood siding along the west side of the homes exterior wall and windows are being constantly sprayed with water when the underground water sprinklers are activated. This is causing damage and surface deterioration to the wood siding in the form of wood rot at various locations. In addition to repairs to sections of the siding, it appears that the water has penetrated further into areas within the building envelope which may have affected other building materials such as the outside plywood sheathing membrane, structural wood framing, insulation, vapour barrier and other unknown building materials. Further investigation is warranted as evidence such as the bathroom windows wood framing sill has wood rot which is an indicator that water has penetrated deeper into the cavity of the exterior wall.

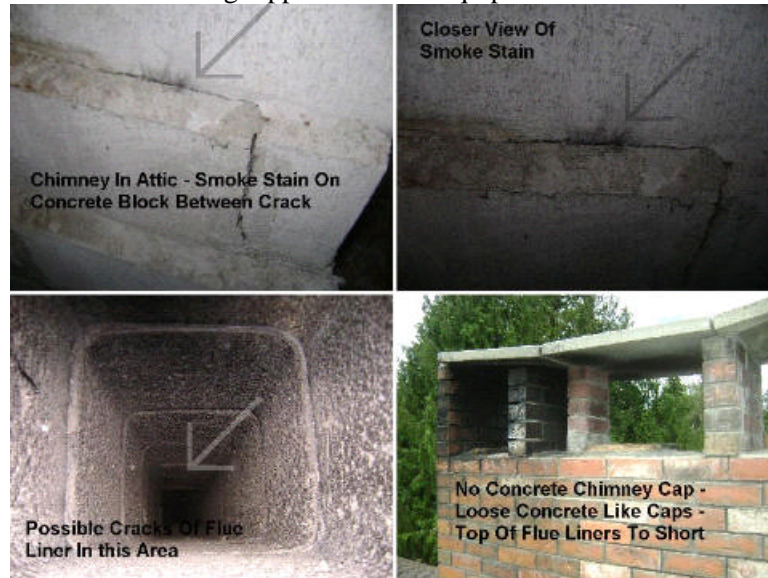
**CHIMNEY LOCATION:** Chimney is located within the interior centre of the home.  
**MATERIAL:** Concrete block.  
**CONDITION:** The following conditions and/or issues are observed at various locations to the chimney:

1. No concrete chimney cap designed and constructed.
2. Small, separate concrete slabs which are supported by bricks are loose.
3. Incorrect clearance to drywall board and wood framing members is observed

4. Appears that the chimney is sharing two separate fuel burning appliances which is the open masonry fireplace and the freestanding wood burning appliance both located within the basement recreation room. This is excepted only if adequate draft is provided and should be proved that such can be maintained.

5. Attic area, observed that several of the concrete blocks at the west side of the chimney are separated from cement mortar.

6. Attic area, observed at where two concrete blocks are separated that black stains are observed on the surface of the blocks indicating that possible smoke spillage may be occurring from inside the flue.

8. Appears that two, possibly more, flue liners are cracked within the chimney as observed, further investigation and inspection is needed.

Need to obtain the professional services of a masonry contractor or Certified WETT Installer to perform the necessary repairs and/or material replacement to the chimney as required by todays building standards and code requirements "Part 9 , Section 9.21. "Masonry and Concrete Chimneys and Flues" British Columbia Building Code 2006 and/or CSA Standards B365-01 "Installation Code for Solid-Fuel-Burning Appliances and Equipment".

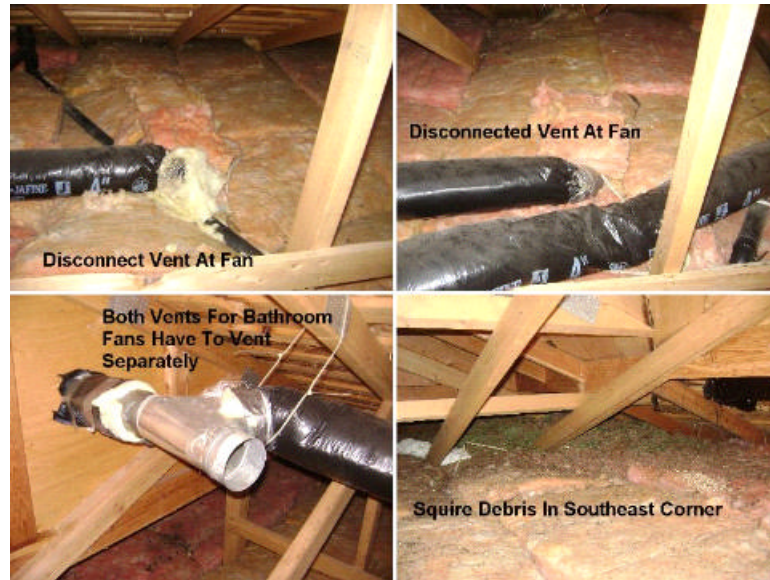
4. Both of the bathrooms vent material are disconnected at the fans and terminate into one single outlet at the west gable end, both need to terminate separately at the exterior with vent covers. Further, both vent pipes are very long in length and therefore, recommend to shorten lengths by terminating both vents at the north side of the roof.

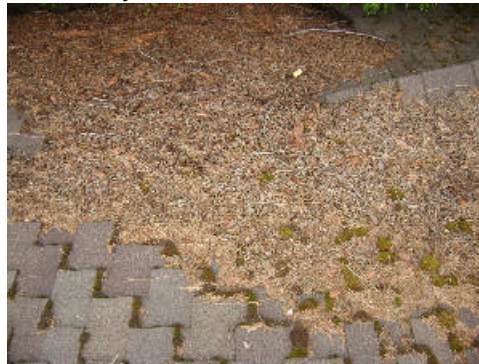
The following conditions and issues to the roofs covering material at various locations are observed:

1. Moss, algae and/or lichens is observed on the surface of the shingles at various locations at the east and north sides of the roof.
2. Roof valleys at the west area of the roof exhibit debris material (water can not flow freely).

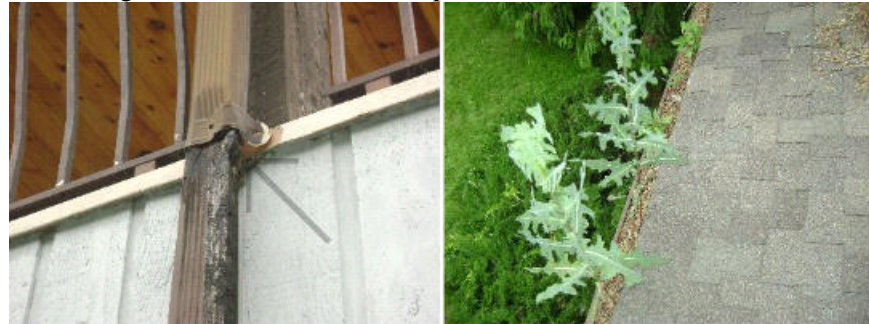
Defects to the drain spouts is viewed at the following locations:

1. Northeast area (damage section of drain spout, loose fasteners, etc).
2. Leaking is observed at the drain spout elbows and/or seams.

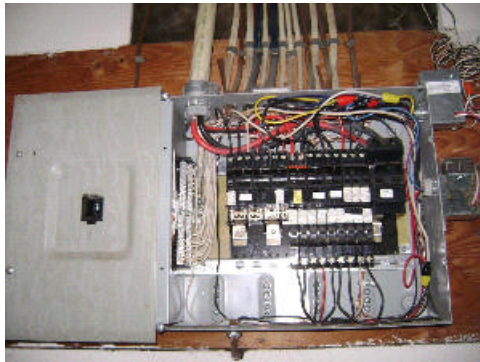
**MAIN PANEL LOCATION AND INFORMATION:**     **Location:** Main electrical service panel is located garage.  
  **Amperage Size:** 200 amp service. 120/240 volt circuit breakers.  
**MAIN PANEL ELECTRICAL CONDITIONS:**     **Type Of Disconnect:** Main disconnect is located at the main panel. Breaker/s type.  
  **Conditions:** Circuit and wiring size appears correct so far as visible. Grounding system is present. Noted that breaker #21 is not marked on the label as to service function.

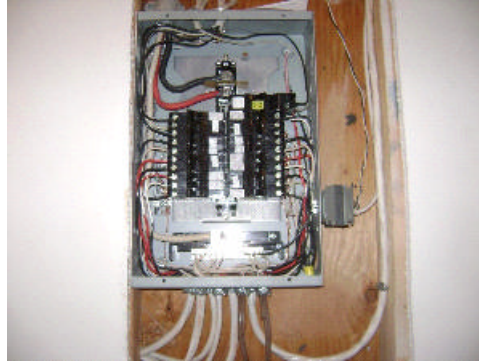
**SUB PANEL LOCATION AND INFORMATION:**     **Location:** Sub panel is located within the south area of the basement (storage room).  
  **Amperage Size:** 100 amp service. 120/240 volt circuit breakers.  
  **Type Of Disconnect:** Main disconnect is not located at the panel but is remotely located at the main panel. Breaker/s type.  
**SUB PANEL ELECTRICAL CONDITIONS:**     **Conditions:** Circuit and wiring size appears correct so far as visible. Grounding system is present. **The following issues are observed at the sub panel:**  
  1. Knock-out covers (plugs) are missing at the outside of the panel to cover open cable entry holes, install knock-out type plug covers where needed (electrical hazard).  
  2. No past electrical permit observed in order to indicate of final electrical

inspection, could be misplaced or lost and therefore, inquire to the homeowner as to its location.

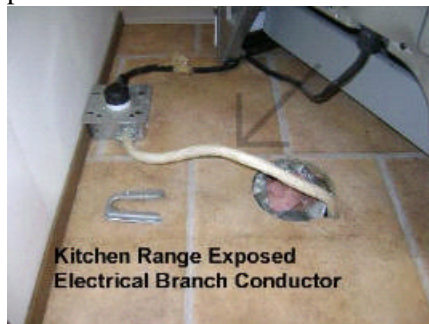
- 1. Kitchen, branch conductor located underside of the cooking range is exposed to potential mechanical injury and is loose (not secured).
- 2. Kitchen, branch conductor located within the bottom back area of the northeast floor cabinets between the right of the sink and left side of the dishwasher is exposed to potential mechanical injury and therefore needs to be protected.

**Kitchen Range Exposed Electrical Branch Conductor**

Obtain the professional services of an electrician to perform further evaluation and perform the necessary corrections to the branch conductors and other related electrical components as and where needed by today's electrical standards and practices.

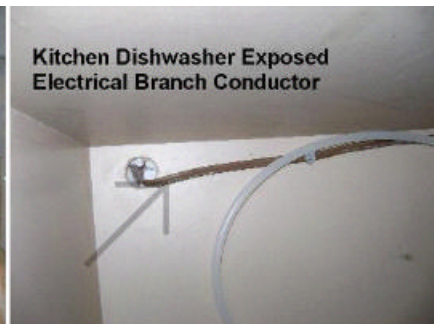
**Kitchen Dishwasher Exposed Electrical Branch Conductor**

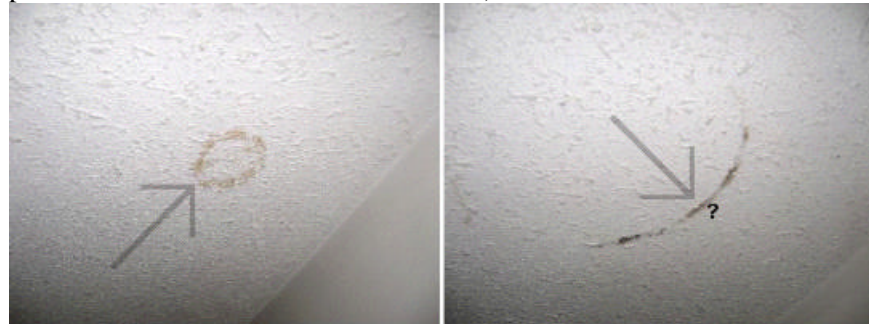
**CONDITION:** General condition appears serviceable with few surface cosmetics noted within the basement recreation/bar area (small dry water stain on drywall board, likely from past water leak from an unknown source).

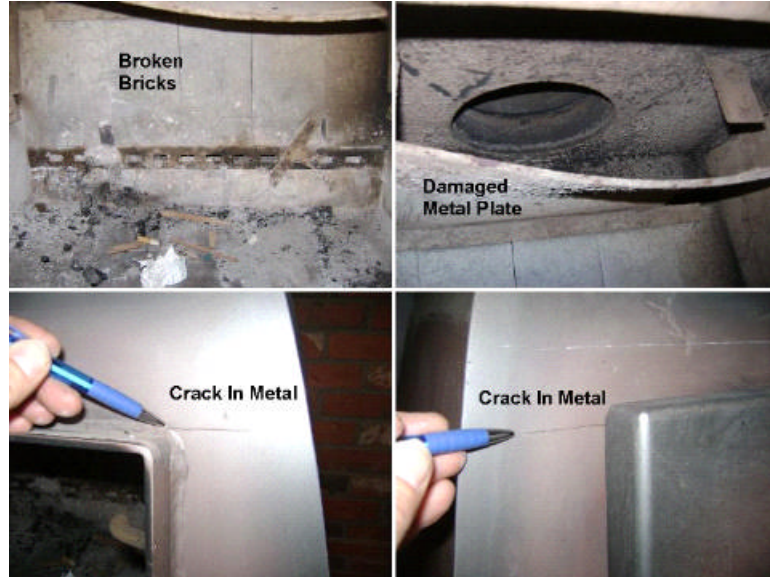
1. Cracks within the metal of the appliance is noted at the front.
2. Several bricks within the fire box are broken.
3. Metal baffle plate within the fire box is damaged.
4. Clearance to combustibles at the front loading door of the appliance is incorrect.
5. Clearance to combustibles of the single wall stove pipe is incorrect.
6. Single wall stove pipe is missing metal screw fasteners at joints.

Due to the present conditions observed at the fuel burning appliance, the continued use of the appliance needs to cease (scrap metal).

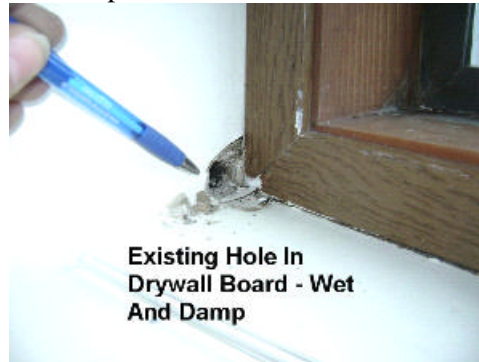
**Observation One:** Basement bathroom, bottom left of window frame. An existing, small finger like hole is observed through the drywall board. Upon observation, the inside area and the surrounding drywall is damaged/deteriorated and wet indicating that outside water/moisture is seeping/entering this area of the bathroom. This likely confirms that the underground water sprinkler spray action against the exterior siding/windows and grade issue at the west side of the home has affected hidden building material within the exterior wall cavity. Need to obtain a professional building contractor to open a section of the interior wall around the window to observe present conditions.

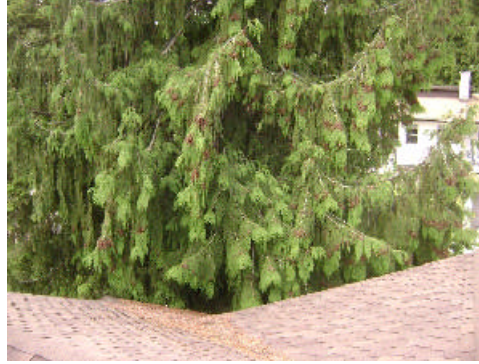
1. Trees are planted close to the home and therefore removal may be needed due to root growth (may affect the foundation of the home), and/or branches are touching the exterior building components (siding, trim, gutters, roofing material, etc).
2. Large shrubs are planted close to the home and therefore removal may be needed due to root growth (may affect the foundation of the home), and/or branches are touching the exterior building components (siding, trim, gutters, roofing material, etc).
3. Trees branches are touching and/or overhanging the roof, damage to exterior building components (siding, trim, gutters, roofing material, etc), is possible. Therefore, all branches must be cut back away from the building.

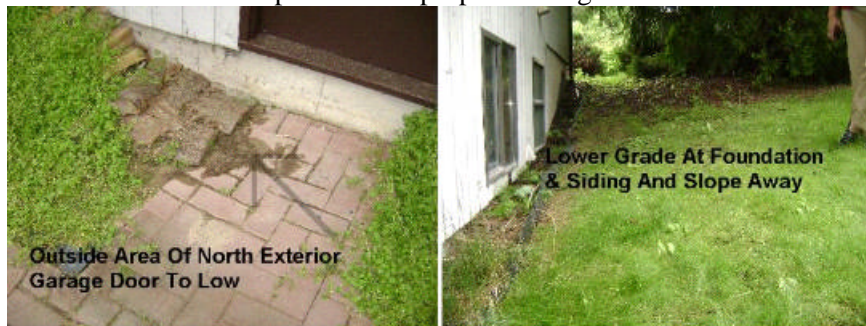
1. North side of the home.
2. South side of the home.
3. West side of the home.

Need to grade slope of soils away from foundation. The slope should fall away from the foundation at a minimum of 1/2 inch per foot and extend at least 10 feet away from the foundation if possible for proper drainage of water.

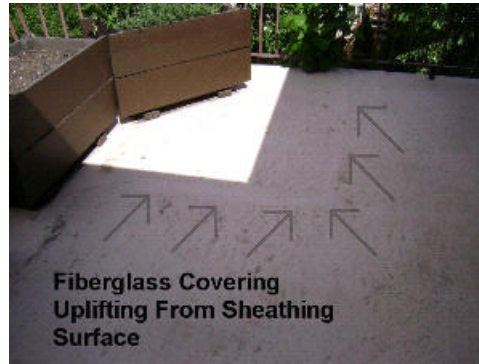
1. Northeast area of the deck, few areas of the fiberglass is separating from plywood sheathing, repairs are needed. Additionally, remove wood flower pots from the deck.
