# **Report Table of Contents**

# INSPECTION INFORMATION & CONDITIONS

**FILE #:** 0000-2011.  
**DATE OF INSPECTION:** May 5th, 2011.  
**TIME OF INSPECTION:** 8:06 am to 11:17 am.  
**CLIENT NAME:** Mr & Mrs Smart.  
**CLIENT ADDRESS:** 1234 Smart Seller Drive  
Shuswap, B.C.

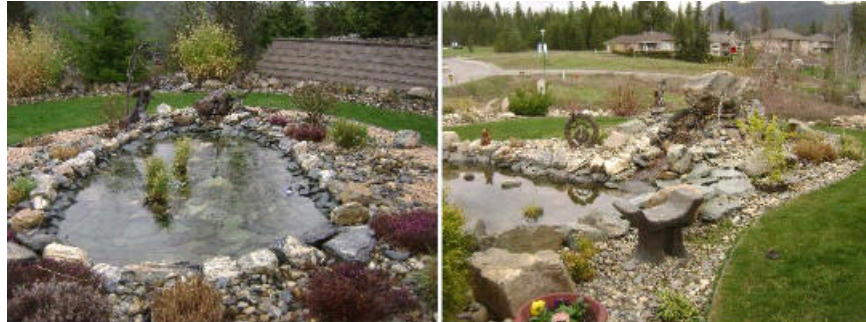
**Photo One:** Decorative Pond - East side of home.

**Photo Two:** Decorative pond - West side of home.

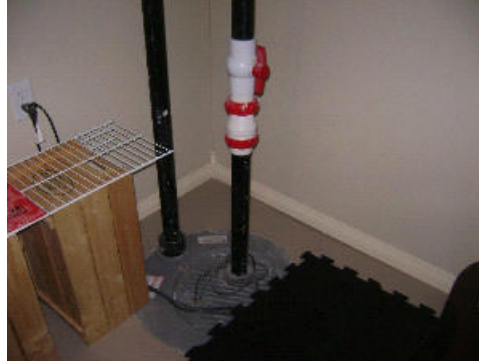
**Floor Drain:** Basement floor drain appears serviceable.

**In-Floor Sump & Waste Liquid / Solid Pump:** Sump installation and condition appears serviceable.

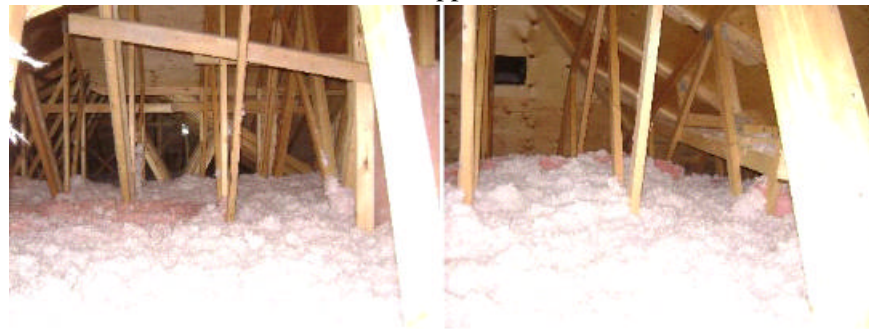
**LOCATION:** Main home.  
**ATTIC SIZE AND ACCESSIBILITY:** **Size:** Attic is full size of the home.  
**Accessibility:** Attic is accessible through the ceiling hatch located in the hallway.  
**TYPE OF ROOF FRAMING:** **Type of Framing:** Truss.  
**Conditions:** Roofing framing appears serviceable where observed.  
**ATTIC CONDITIONS:** General conditions within the attic appears to be serviceable.

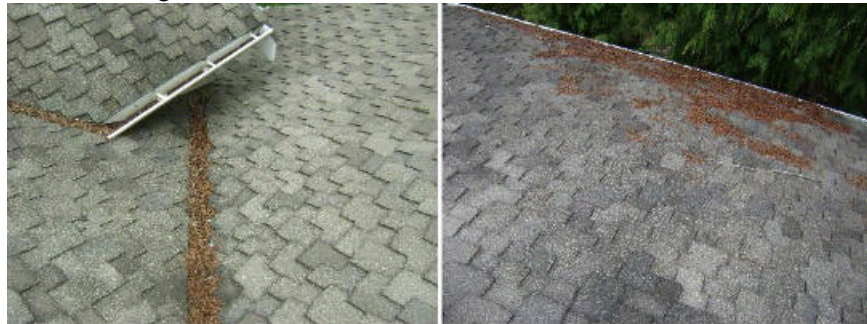
**STYLE:** Gable type roof.  
**TYPE:** Asphalt shingles.  
**ROOF SHEATHING MATERIAL:** **Type:** Type of sheathing material membrane installed is plywood, (4x8) sheathing. H clips have been installed between the joints of the sheathing membrane.  
**Condition:** Appears serviceable where observed.  
**UNDERLAYMENT:** N/A.  
**ROOF ACCESS:** Walked upon roof surface.  
**ROOF COVERING STATUS:**

1. Clean tree debris from valleys to allow the free flow of water to the gutters.
2. Remove tree debris from the surface of the roof at the south side.
3. Remove light moss from the surface of the roof where observed.

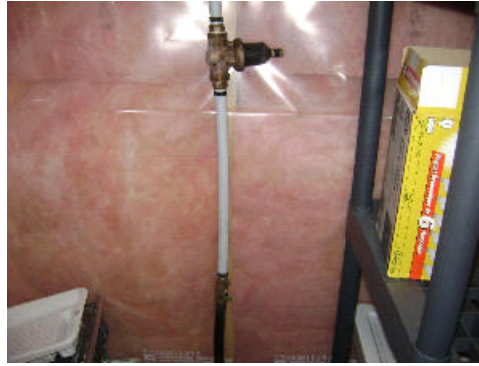
<b>MATERIAL:</b>	Plastic.
<b>LOCATION AND</b>	<b>Location:</b> The main water line is located in the basement utility room.
<b>CONDITION:</b>	<b>Size:</b> Main water line size is 3/4 inch diameter. <b>Condition:</b> Main water line appears in good condition as observed. Main water shut off valve appears serviceable (operational). Water pressure appears adequate. Water pressure valve regulator is installed and appears serviceable.

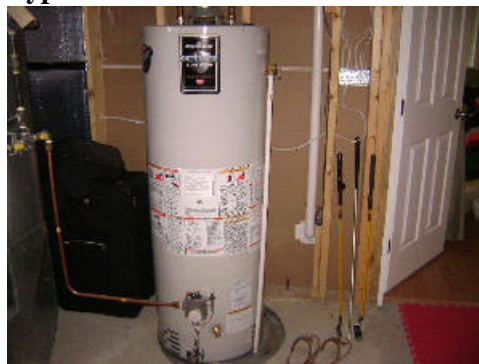
**LOCATION:** Hot water heater is located in the basement utility room.  
**TYPE:** **Manufacture:** Bradford White.  
**Model #:** MI504S8FBN7.  
**Serial #:** BM7072060.  
**Type:** Conventional water heater.

**FUEL SUPPLY:** Gas fueled.  
**SIZE:** 50 gallons.  
**CONDITIONS:** **Conditions:** Appears serviceable (operational). Pressure relief valve installed with no visible water leakage, not tested. Flue vent appears serviceable. A water shutoff valve is installed, appears serviceable (no water leakage observed). Pilot light appears serviceable. Burner appears serviceable.

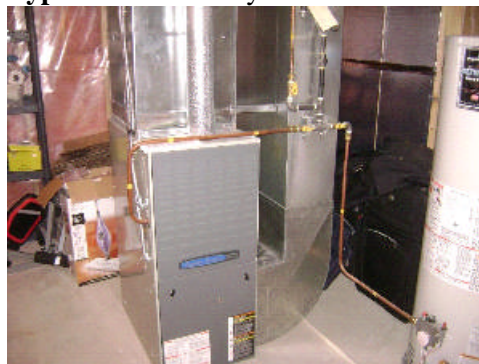
**HEATING UNIT INFORMATION:** **Manufacture:** American Standard.  
**Model #:** AUD1B100A9361AA.  
**Serial #:** 6015UD21G.

**Type:** Mid efficiency furnace. Electronic ignition is provided.

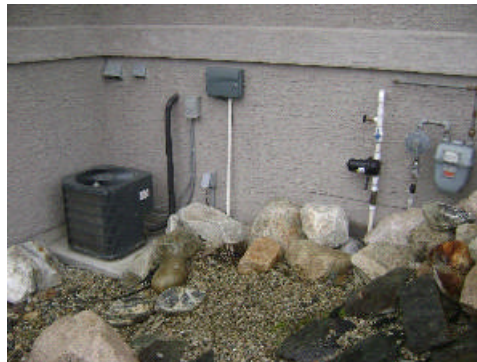
**TYPE & UNIT INFORMATION:** **Location:** Central air conditioning system with main unit located at the north side of the home.  
**Manufacture:** Goodman.  
**Model #:** CKL-30-1L.  
**Serial #:** 0601760063.

**POWER SOURCE:** 240 volt service. Electrical disconnect is present at or near the A/C unit.  
**COMPRESSOR AGE IN YEARS:** Unknown.  
**CAPACITY OF UNIT:** N/A.  
**CONDENSATE LINE:** Condensate line installed.  
**RETURN AIR TEMPERATURE:** N/A.  
**SUPPLY AIR TEMPERATURE:** N/A.  
**AIR TEMPERATURE DROP:** N/A.  
**SYSTEM CONDITION:** Outside air temperature at this time of the year is below 20 degree' s C. Because of these cold/cooler temperatures, if A/C unit is operated it could damage internal components within the unit, therefore, unable to test system at this time.

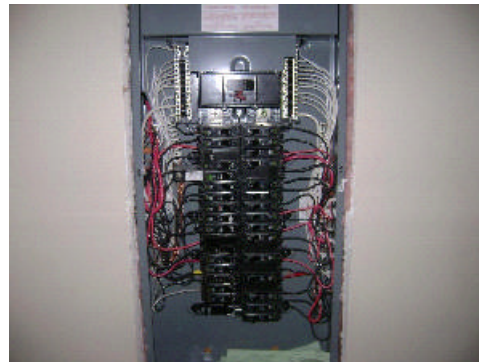
**MAIN PANEL LOCATION AND INFORMATION:** **Location:** Main electrical service panel is located in the basement work-out room.  
**Amperage Size:** 200 amp service. 120/240 volt circuit breakers.  
**Type Of Disconnect:** Main disconnect is located at the main panel. Breaker type.  
**Conditions:** Circuit and wiring size appears correct so far as visible. Grounding system is present.

## **MAIN PANEL ELECTRICAL CONDITIONS:**

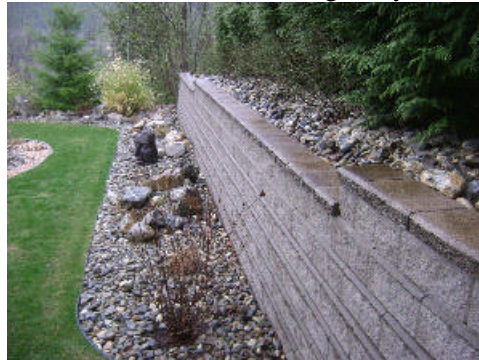
**Conditions:** Retaining wall by outward appearance appears serviceable (other areas pertaining to the retaining wall that are buried from viewing, conditions, design and construction unknown).

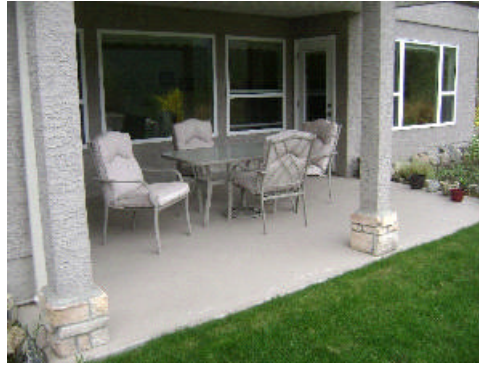
**Type:** Concrete.

**Condition:** Appears serviceable.

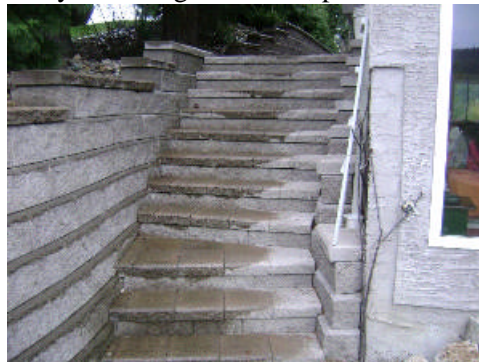
**Condition of Stairs:** Stairs appear serviceable.

**Condition of Hand Rails:** Obtain the professional services of a builder or renovation contractor to install a set of handrails along the sides of the stairs by today's building standards, practices and code requirements.

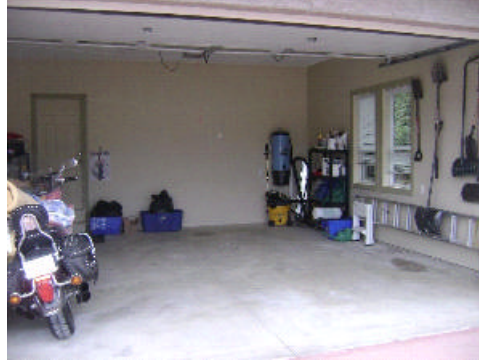
Garage is located at the southwest area of the home.
