# **Report Table of Contents**

# INSPECTION CONDITIONS

**FILE #:** 2746-2010.  
**DATE OF INSPECTION:** July 5th, 2010.  
**TIME OF INSPECTION:** 10:26 am to 3:38 pm.  
**CLIENT NAME:** Mrs Jon Jet.  
**CLIENT ADDRESS:** 1111 Anywhere Street  
Salmon Arm, BC.  
**CLIENT PHONE #:** 250 111-1111.  
**EMAIL ADDRESS:** greathome@unknown.ca.  
**INSPECTION SITE ADDRESS:** 2222 Homes Street  
Blind Bay, BC.

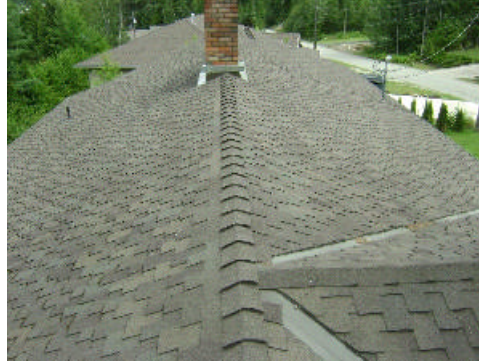
**TYPE:**

Asphalt shingles.

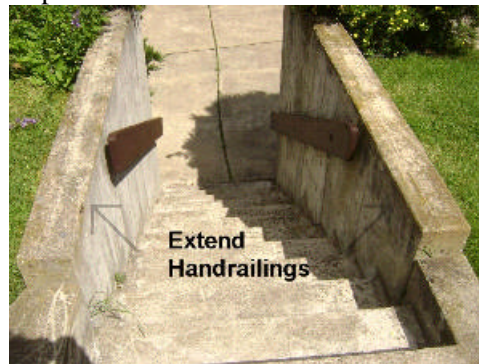
## EXTERIOR STAIRS:

**STAIRS & RAILINGS ONE:** **Location:** Stairs are located at the south area of the property.  
**Condition of Stairs:** Stairs appear serviceable.  
**Condition of Hand Rails:** Stairs handrail appears serviceable but should be extended at the top in order to grasp the handrailing firstly before stepping onto the steps.
