Report Number: 2721-2010

Inspection Address: Clean Chimney Drive
Burnville, BC.

Wood Stove and Flue Pipe Inspection

Masonry Chimney Inspection

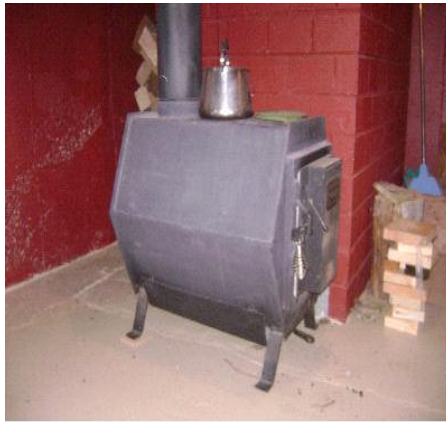
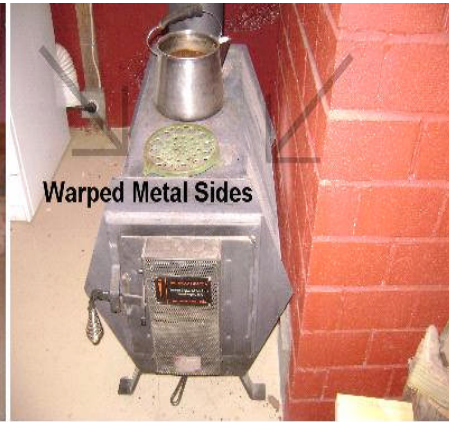
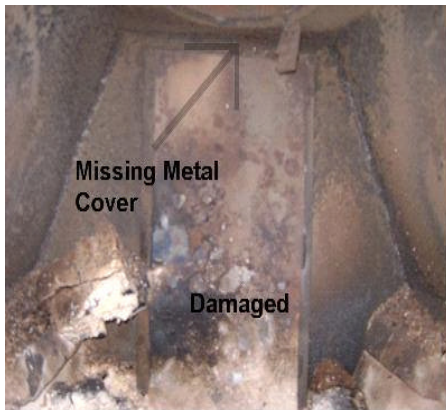
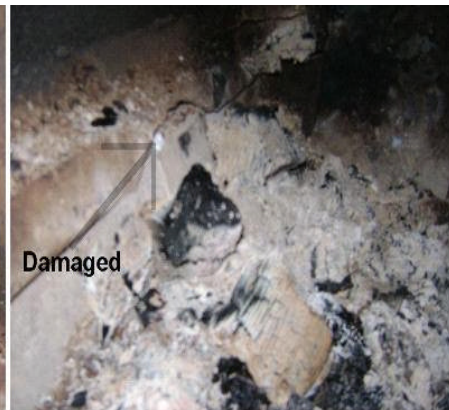
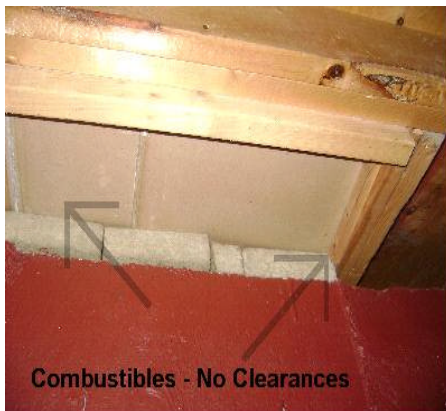
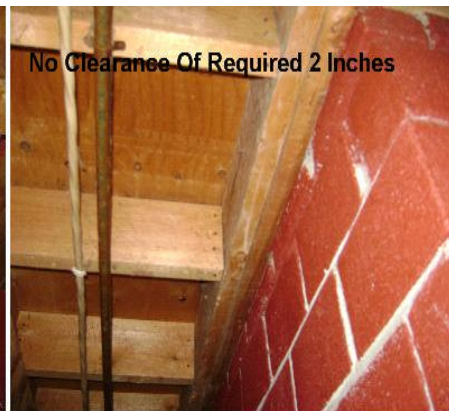
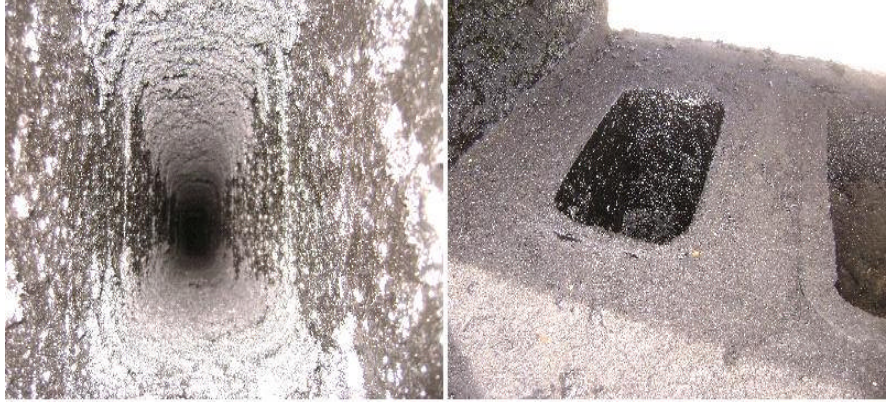
- 1.1. Metal brach pipe within the masonry chimney is loose.
- 1.2. The back metal plate within the fire box is damaged and warped.
- 1.3. The metal holding brackets at the right and left inside of the fire box that hold the bricks are damaged.
- 1.4. The metal baffle cover inside the fire box is missing.
- 1.5. The outside top left and right sides of the appliance metal is warped.

2.0. Single Wall Stove Pipe: Installation does not meet CSA Standards B365-01.

3.0. Chimney: Due to the current conditions and issues, the chimney can no longer be used at this time.

4.0. Conclusion: Appliance and stove pipe can no longer be used for their intended purpose (scrap). Further, the flue liner needs to be cleaned and the inside needs to be inspected for current conditions with the use of a video camera. Additional, all clearances around the outside of the chimney has to have an air space of 2 inches or greater from combustibile materials.
